Structural Assessment Blog

Blog Date: 7/22/15

Boone, North Carolina

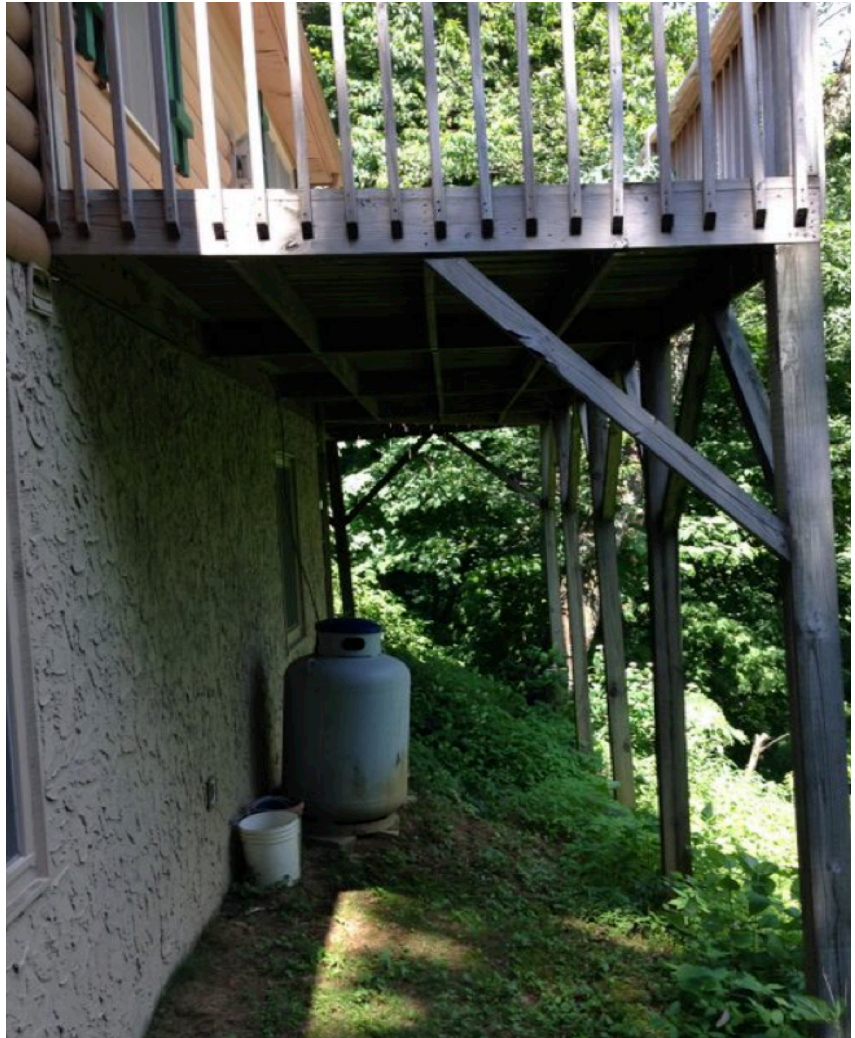
2

Like many structures built in the mountains, the unique topography causes these residences to be extremely susceptible to settlement and other structural concerns. This particular residence was constructed on top of fill material that began to settle in the downhill direction.

The combination of poor construction practices, steep grade conditions, and water erosion caused the foundation wall to settle and crack. In addition, the timber deck also showed severe signs of settlement.

-in this region of the country, fill material on a slope steeper than 2:1 is highly unstable and susceptible to settlement. Due to geometry constraints, sometimes builders are forced to build on slopes steeper than 2:1, if this is the case some standard building practices should take place. The foundation of the residence should always go down to residual (untouched) soil, or rest on reinforced soil in order to achieve proper stability. Gutter pipes and water runoff should terminate below the toe of the fill material to protect from erosion. If possible, do not build within 10 feet of where the fill slope breaks downhill.
