# Structural Assessment Blog

Blog Date: 8/13/15

Boone, North Carolina

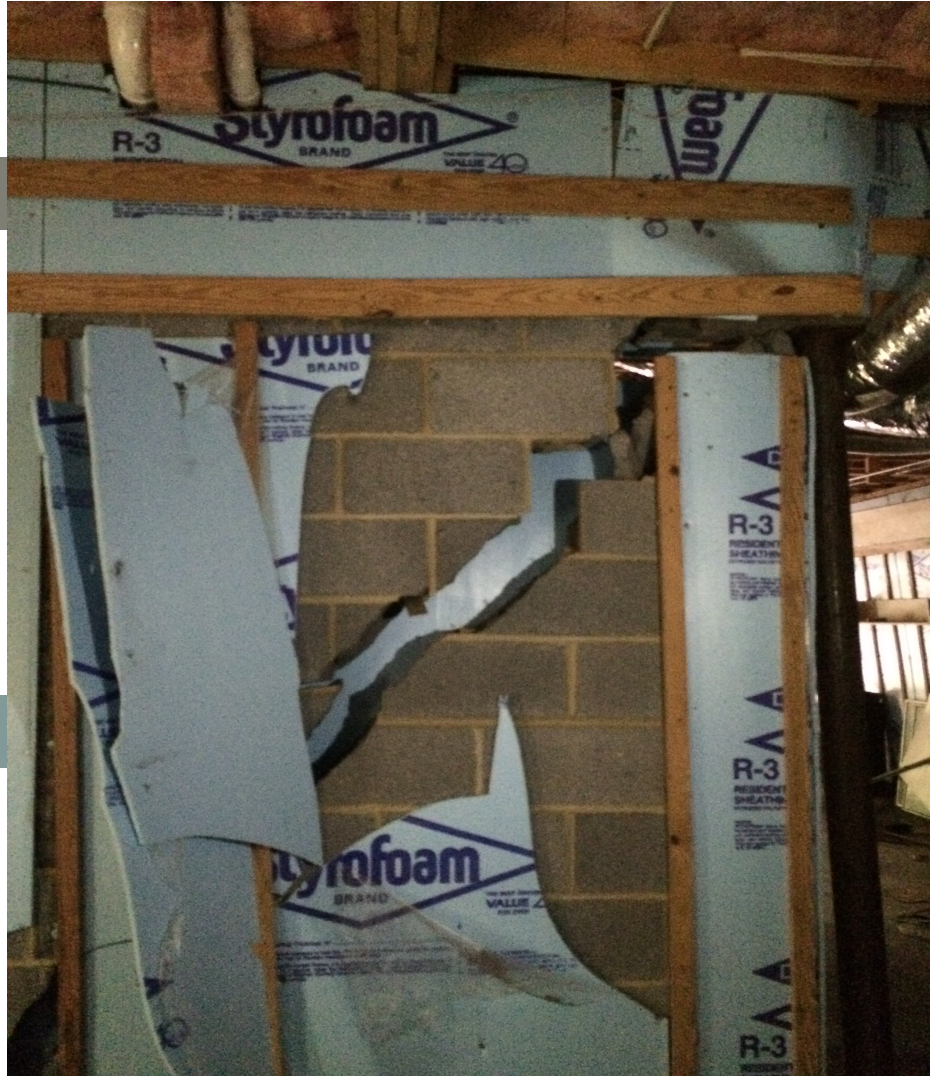
3

The purpose of a shear wall is to help support the load exerted on the uphill wall from the weight of the fill material, however when these walls are built incorrectly an extreme amount of force is applied to the uphill wall. In this case the shear wall has failed and the uphill wall is bowing in, causing the entire residence to tilt down hill.

- Unfortunately this particular residence is too far-gone in order to be salvaged. As you can see in the picture above (failed shear wall) the combination of poor construction and heavy lateral earth pressure can have serious consequences. The foundation of this house was extremely under designed for the amount of force the fill material would have against it. Large openings in shear walls close to the uphill side causes the shear wall to become weak under extreme loads. We also recognized signs of mold and severe water infiltration on the uphill side of the residence, which led us to believe that there was an absence of a water proofing membrane on the outside face of the CMU foundation wall. The implementation of gravel between the foundation wall and the fill material is a must in order to properly drain ground water away from the wall and into a collection drain resting on top of the footer. We believe that clayish fill material, which is susceptible to settlement, was put directly against the foundation with out the use of gravel further adding to the long list of problems.
